Orbital Transfer Rocket Engine Technology Program

Contract NAS3-23773
Task B.5

Soft Wear Ring Seal Technology

FINAL REPORT

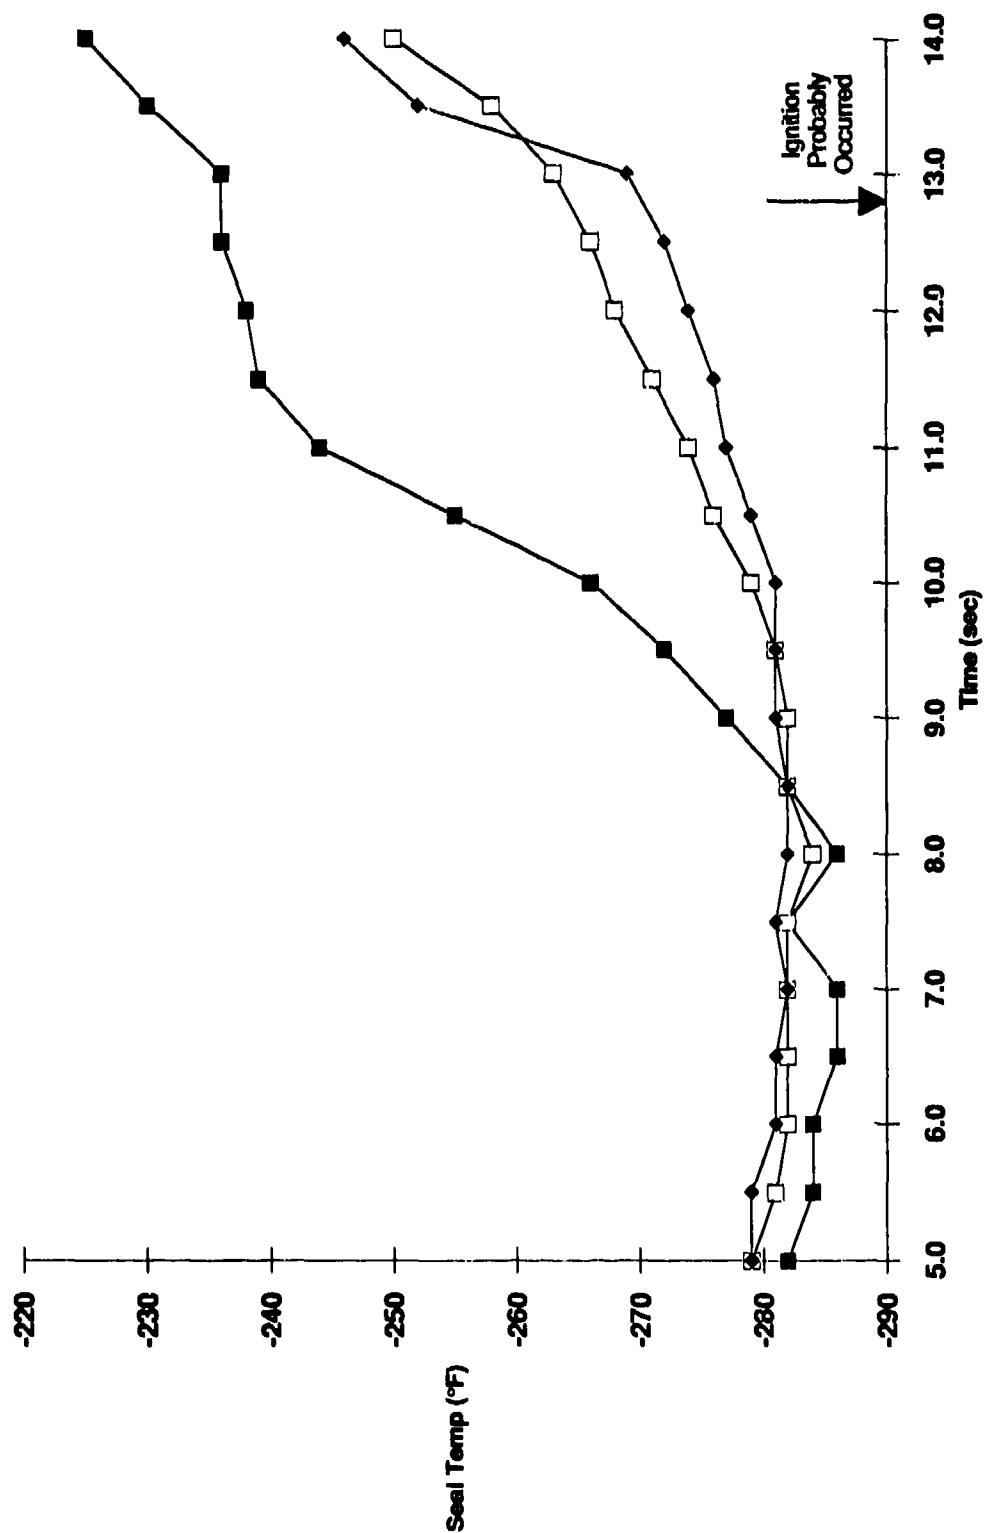
Figure 28

Test WS31: Temperature Distribution

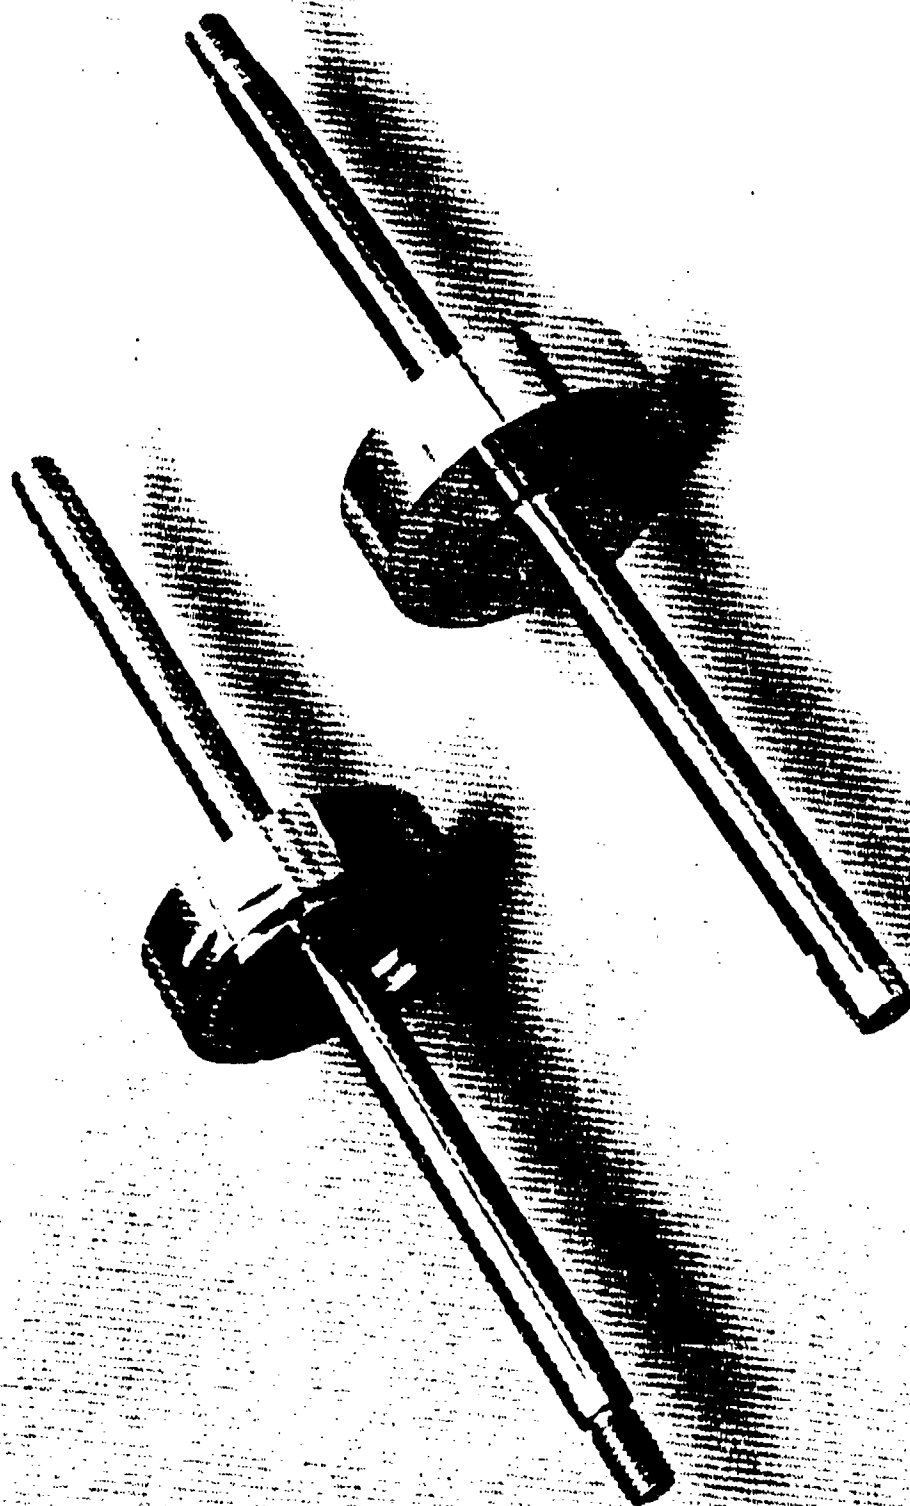
Figure 30

Low Speed Friction and Wear Tester Re-Designed Rotor Specimens

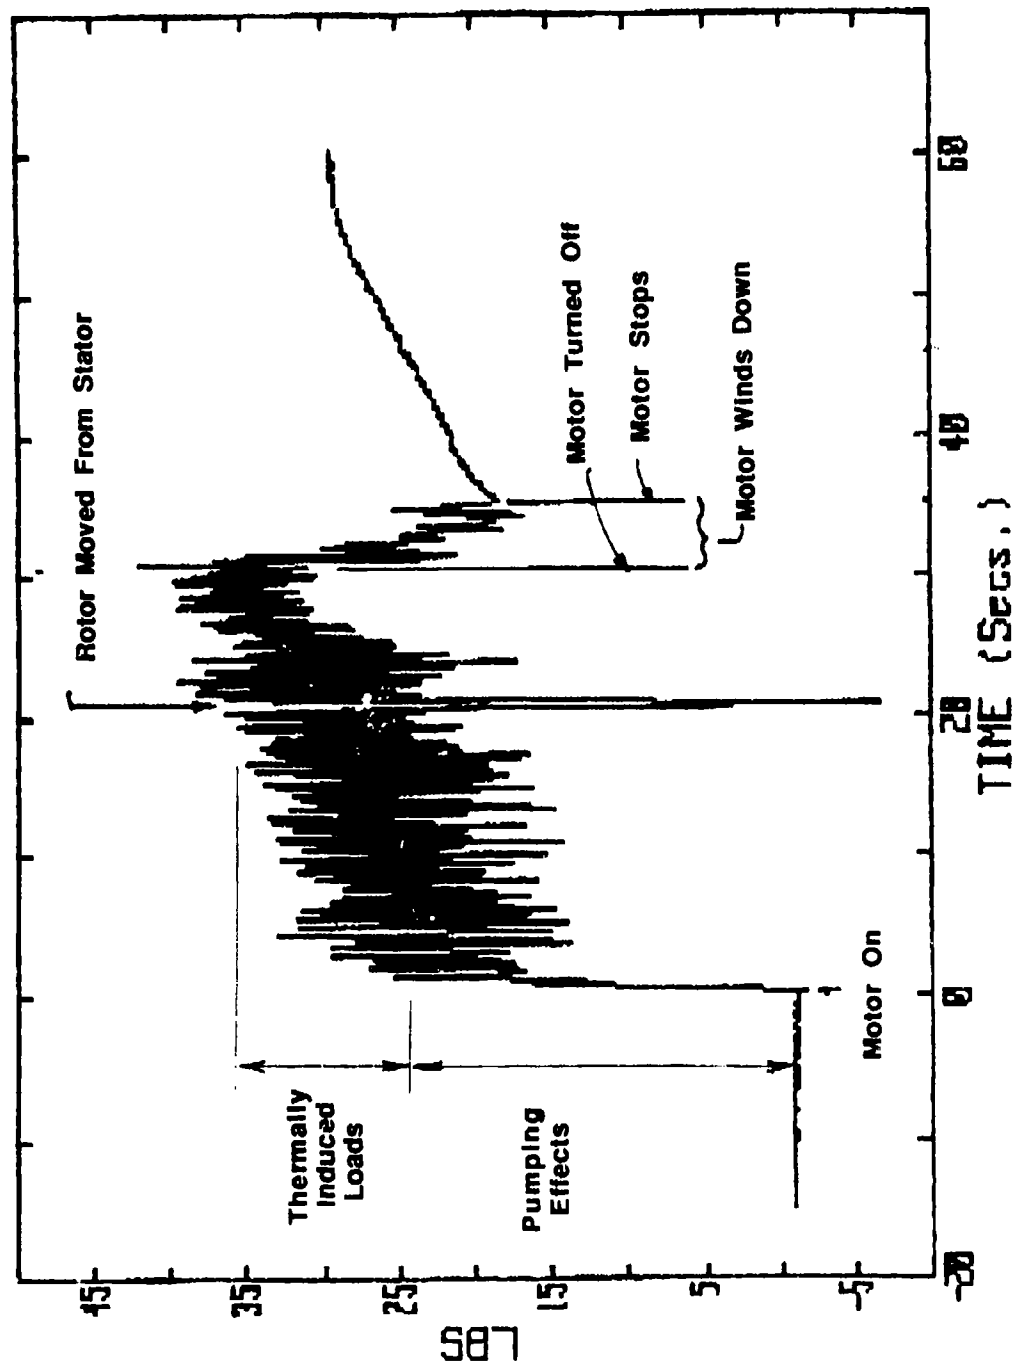
Figure 31

Test WS01C: Axial Load vs Time

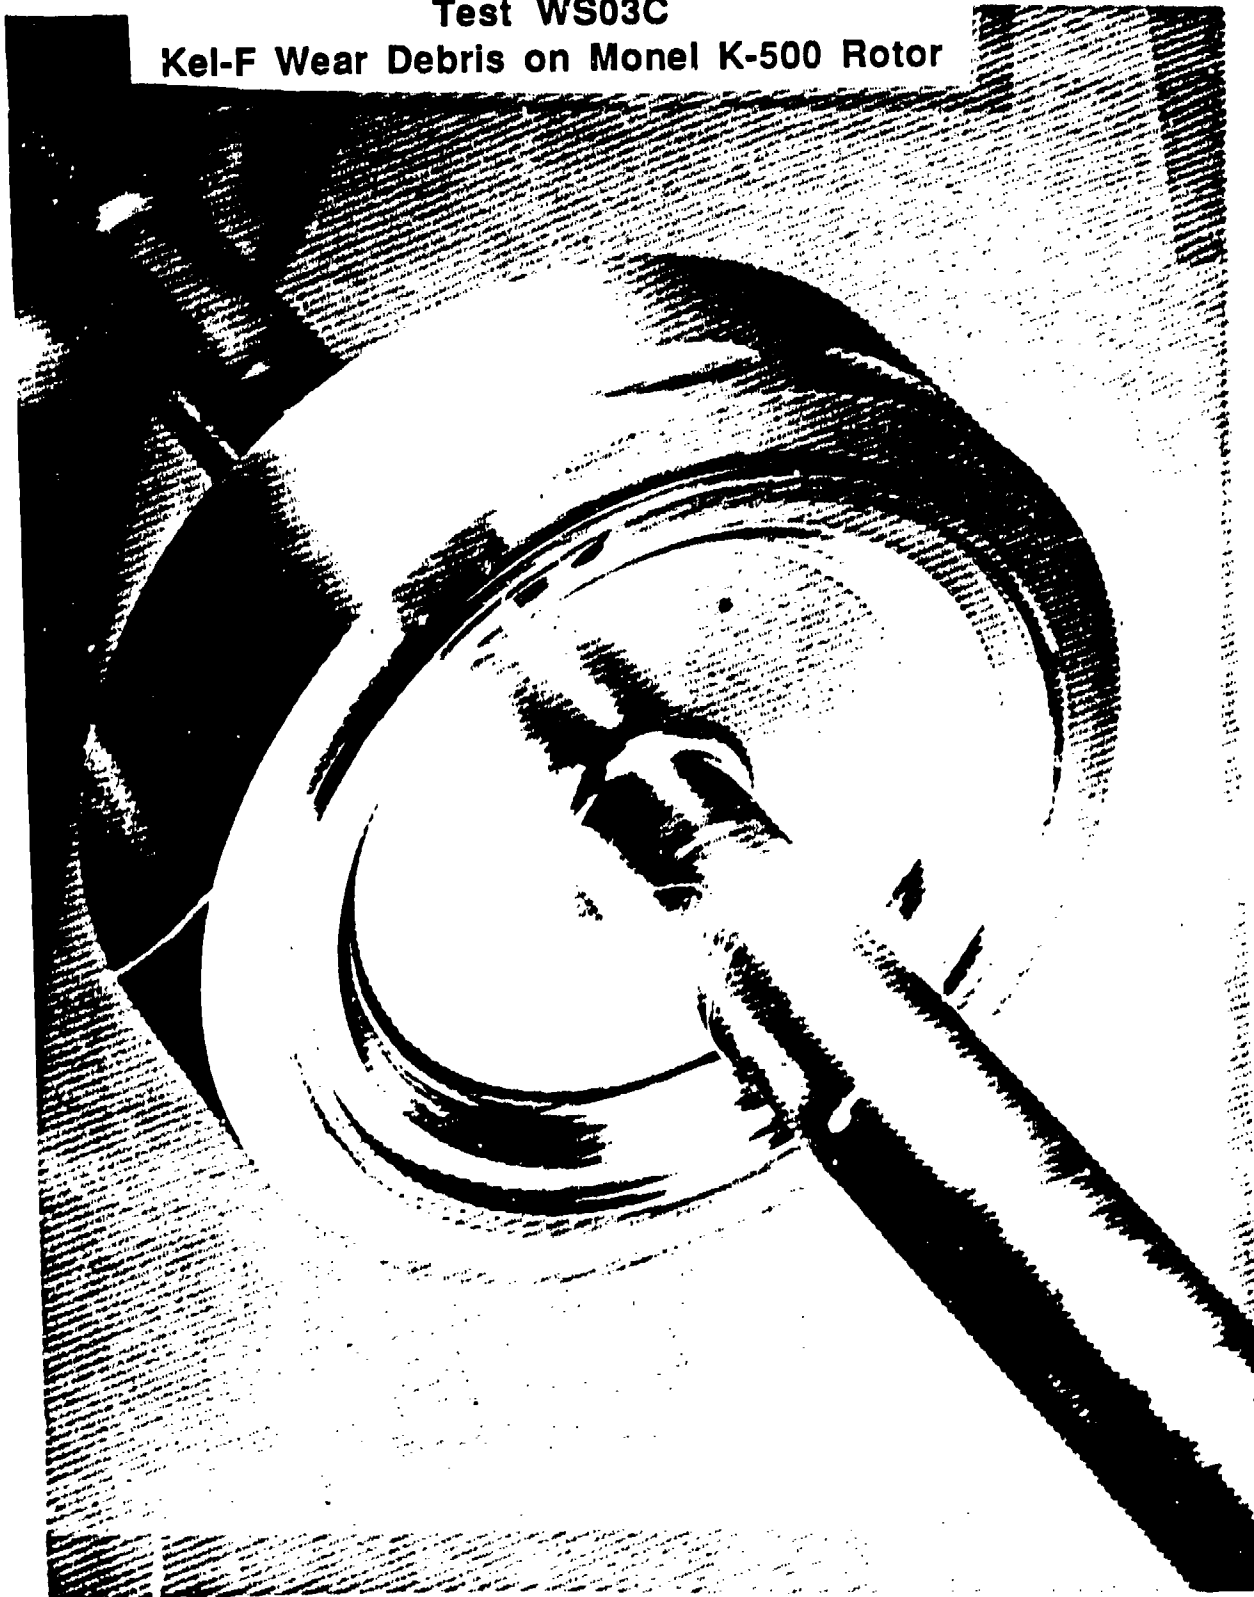
Figure 33

Test WS03C
Kel-F Wear Debris on Monel K-500 Rotor

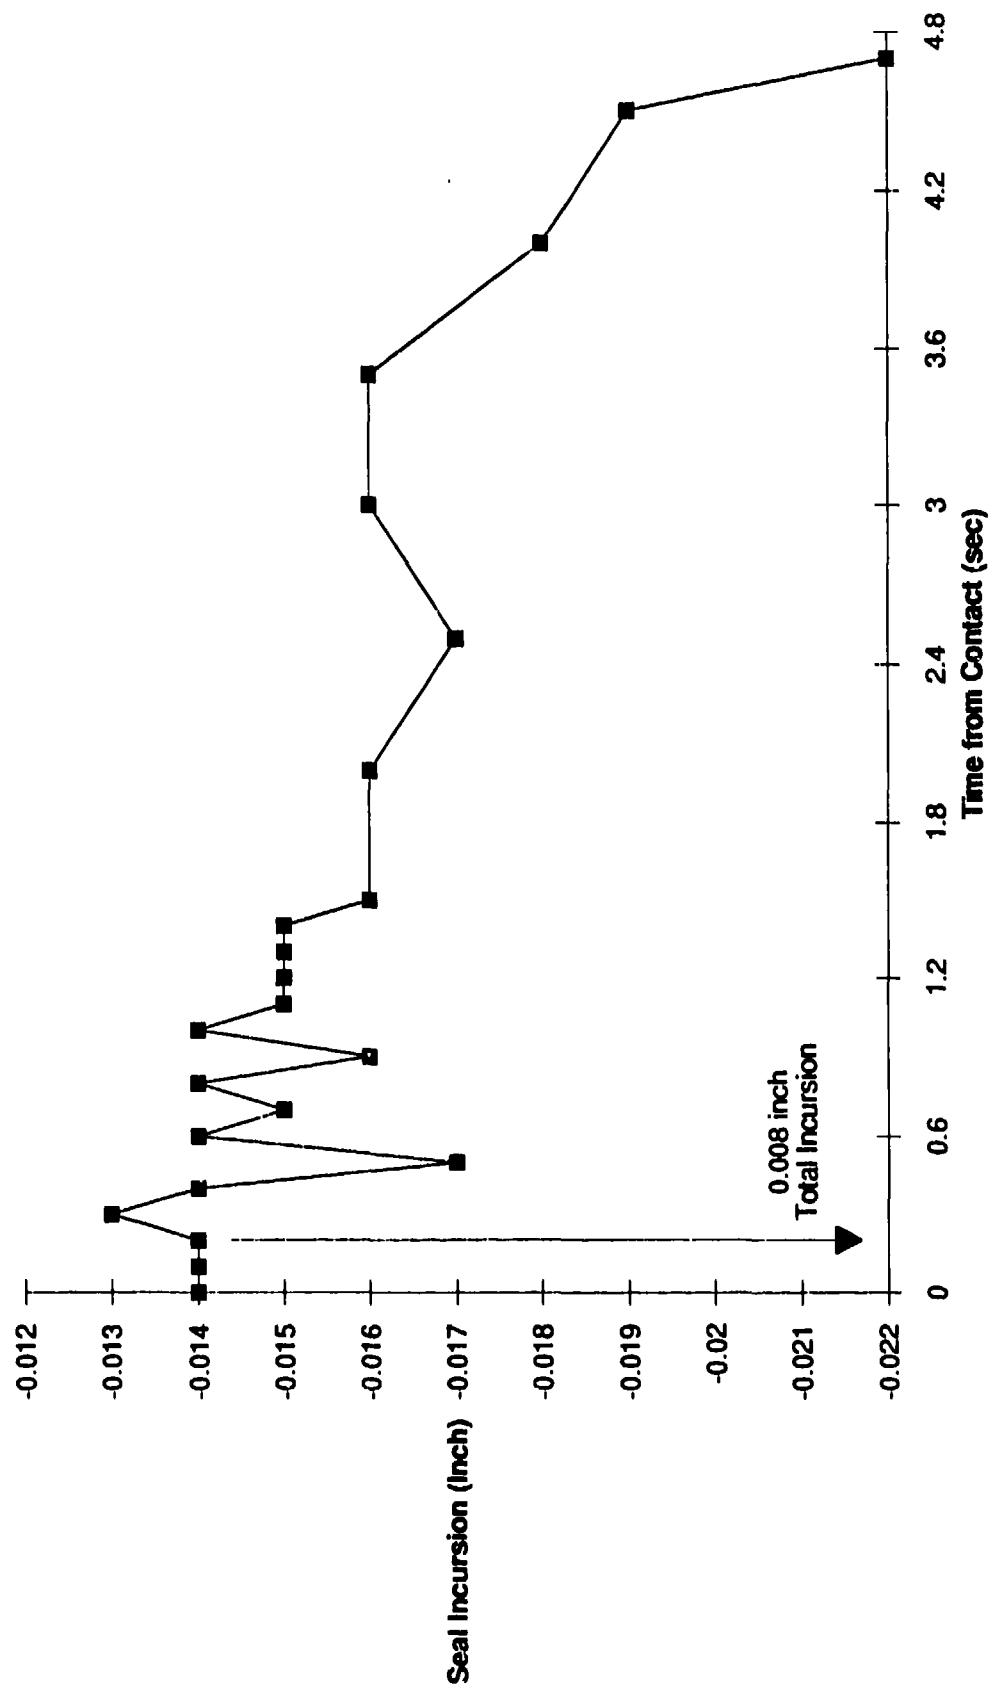
Figure 34

Test WS03C: Incursion from Time of Contact

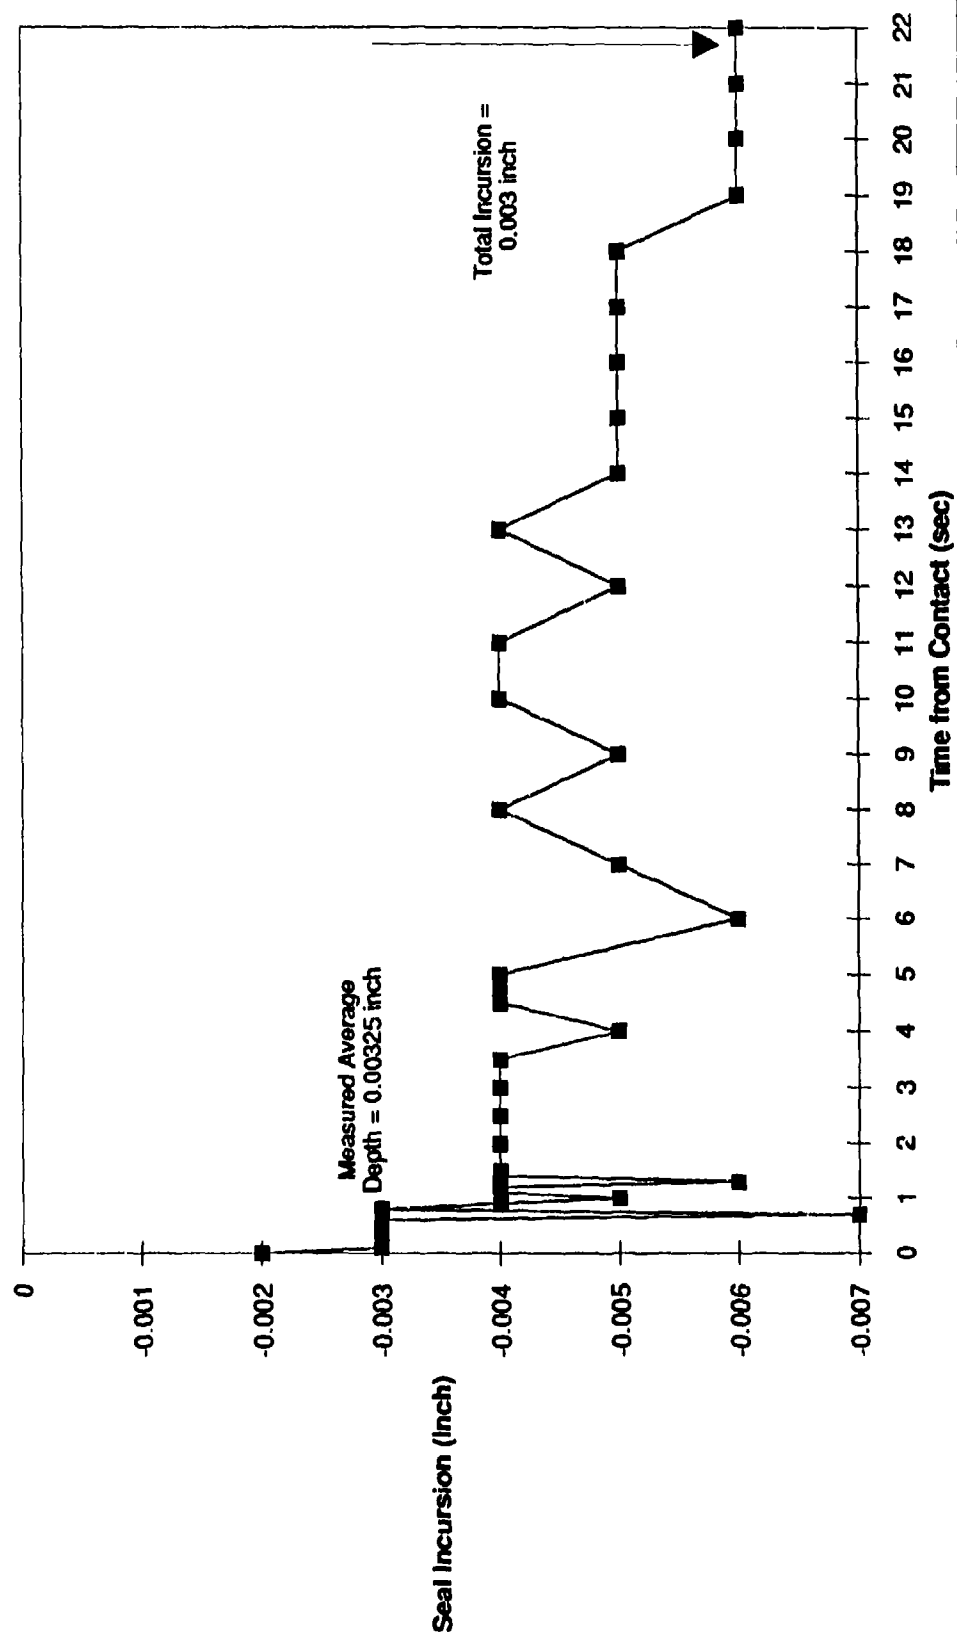
Figure 35

Test WS04C: Incursion from Time of Contact

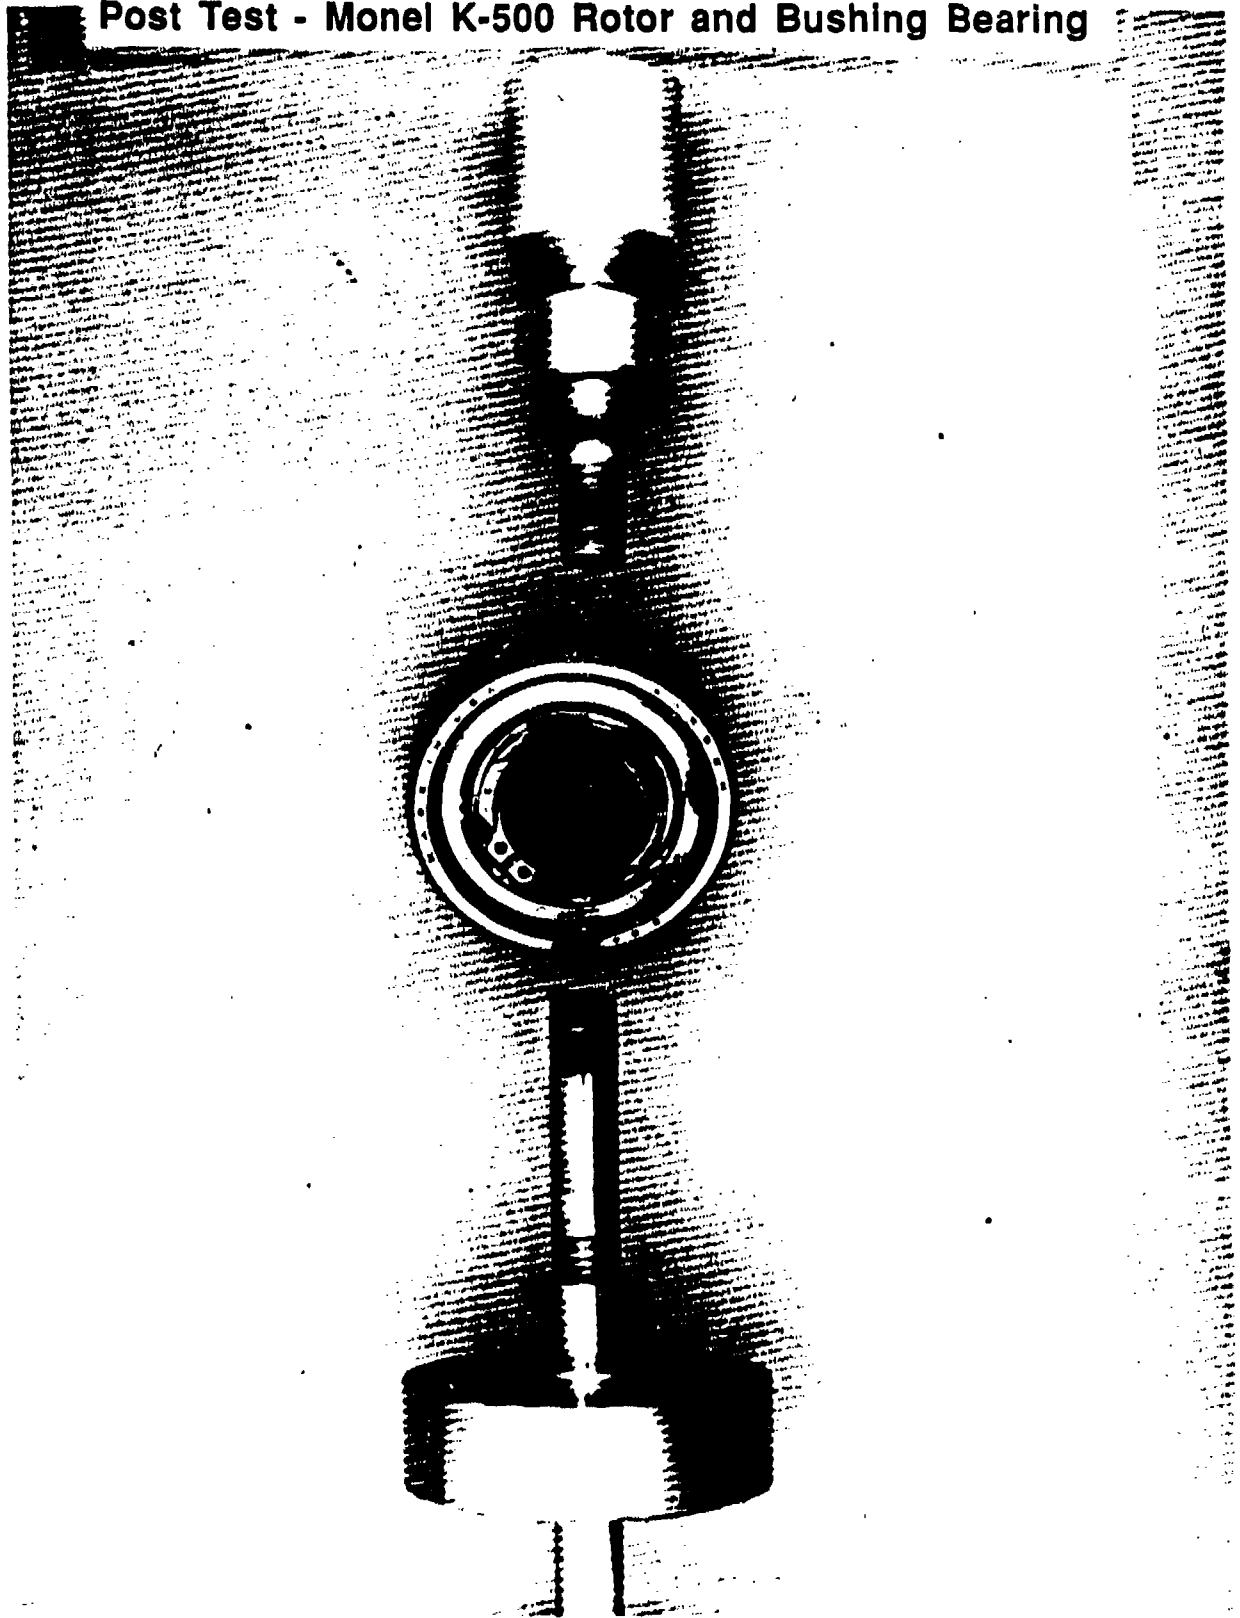
Figure 39

Test WS04C

Post Test - Monel K-500 Rotor and Bushing Bearing

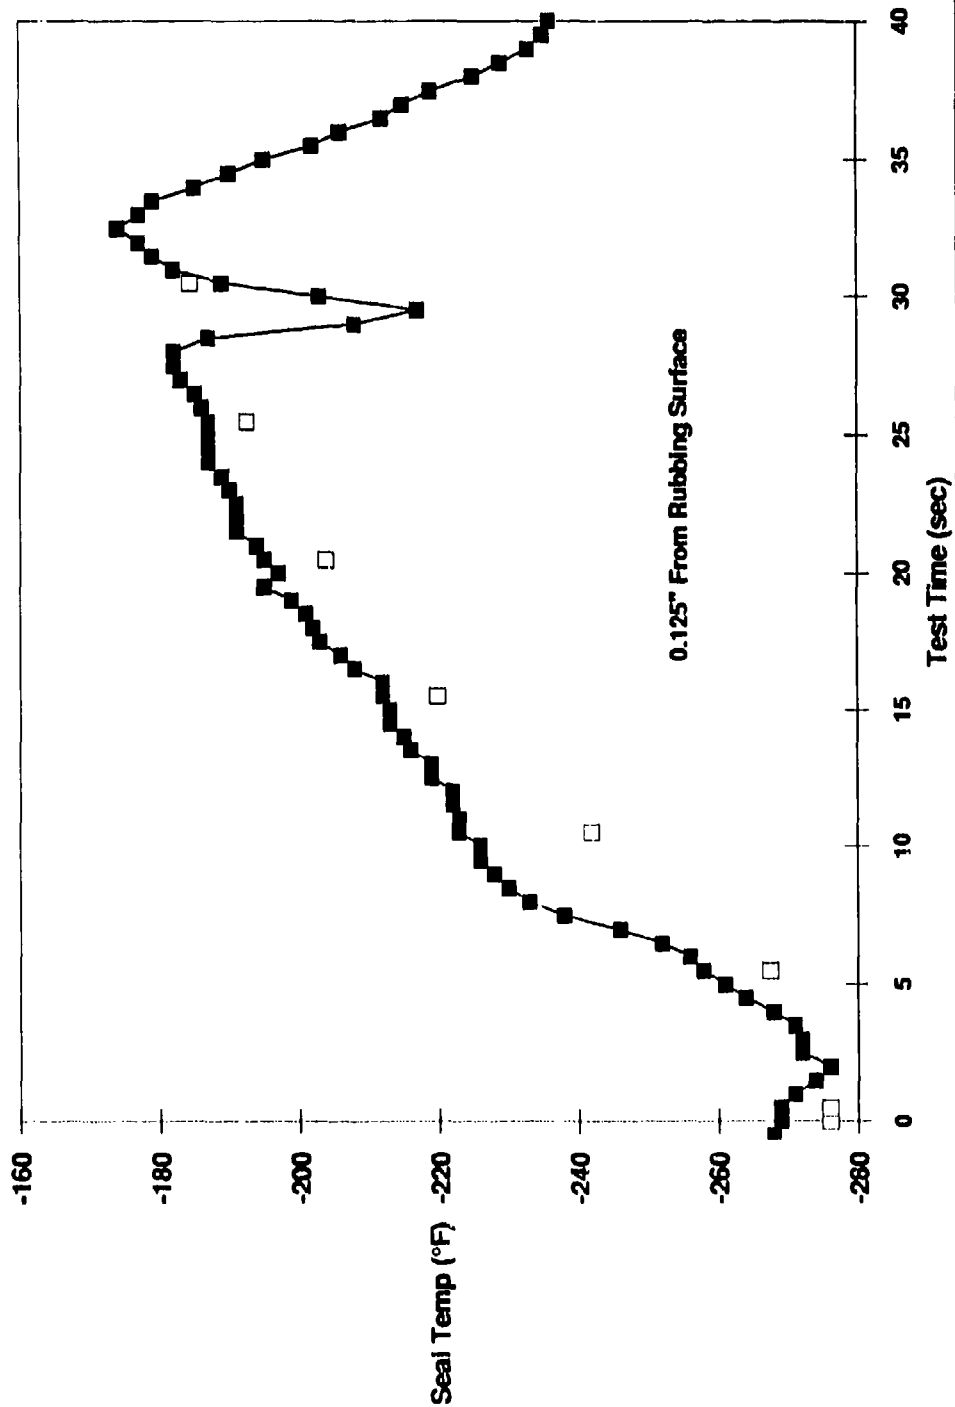
Figure 42

Test WS30F: TC-702 vs Frictional Heating Model

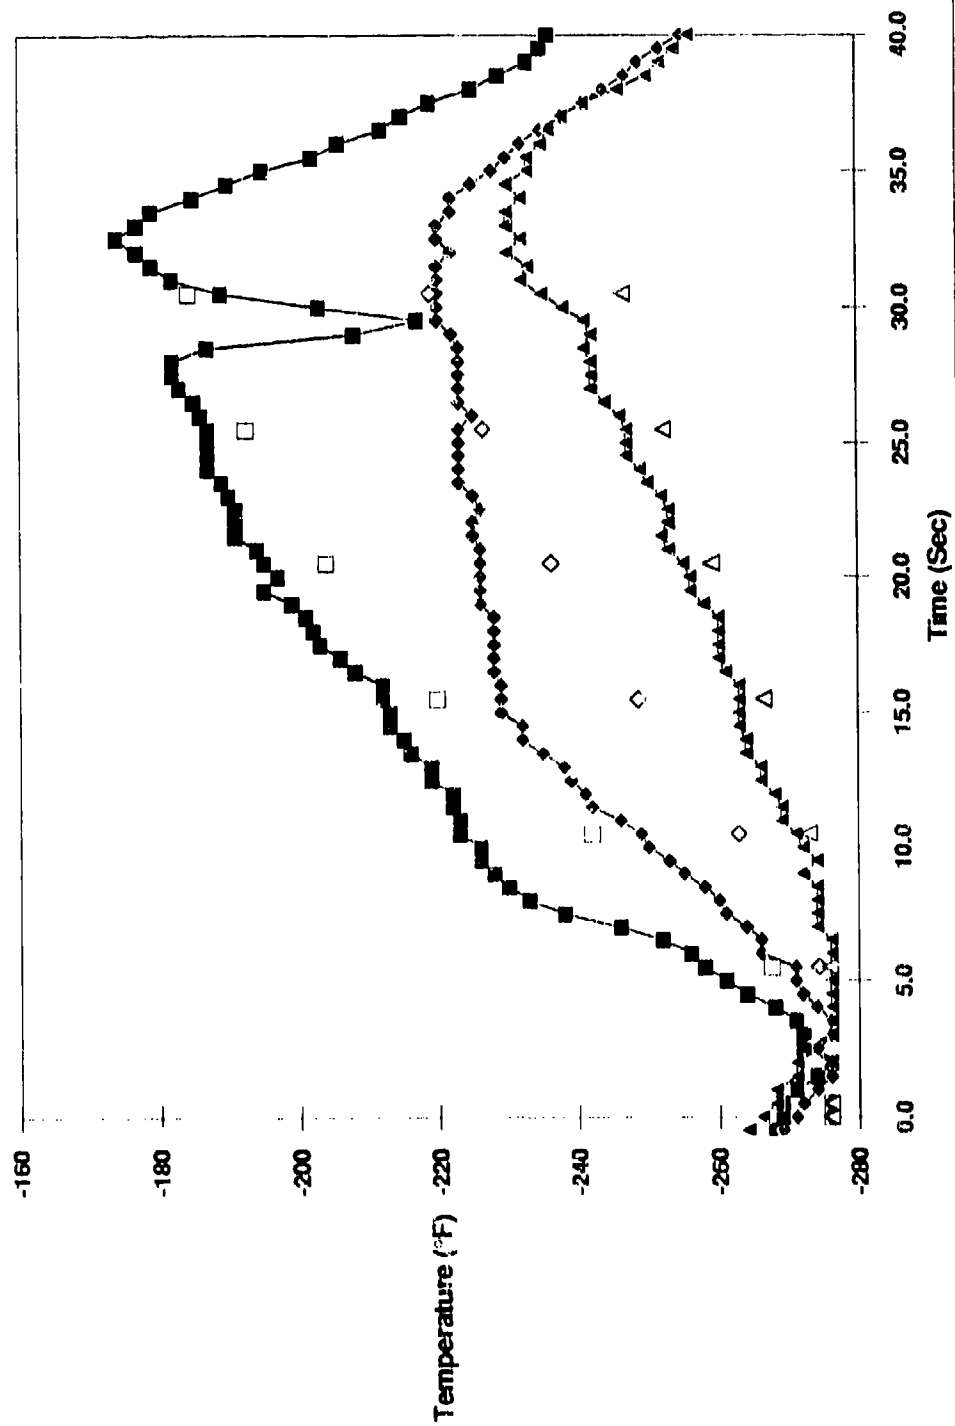
Fig 45

Test 30F: Data vs Frictional Heating Model Comparison

total heat load applied to the rubbing surface of the thermal model required to match the thermocouple data, was about 3.14 BTU/sec. The heat of reaction of the Vespel, as it burned, probably dominated the overall heat transfer into the seal, causing a much higher heat load. Therefore, the chemical heat rate term, instead of dissipating heat, was generating additional heat. Frictional heating from the rotor was only about 0.338 BTU/sec, whereas the estimated heat emersed by the reaction was about 2.80 BTU/sec (more than eight times greater than the frictional heat load). **Figure 46** compares the model predictions against the actual measured thermocouple data prior to the termination of the test. The tapered contact tooth of the test rotor developed a larger contact area as incursion increased, reducing the contact stress. However, the incursion data during this test was difficult to interpret, so a constant contact area was used (rotor tip area). This is not entirely realistic, and imposed a higher heat flux than was actually applied.

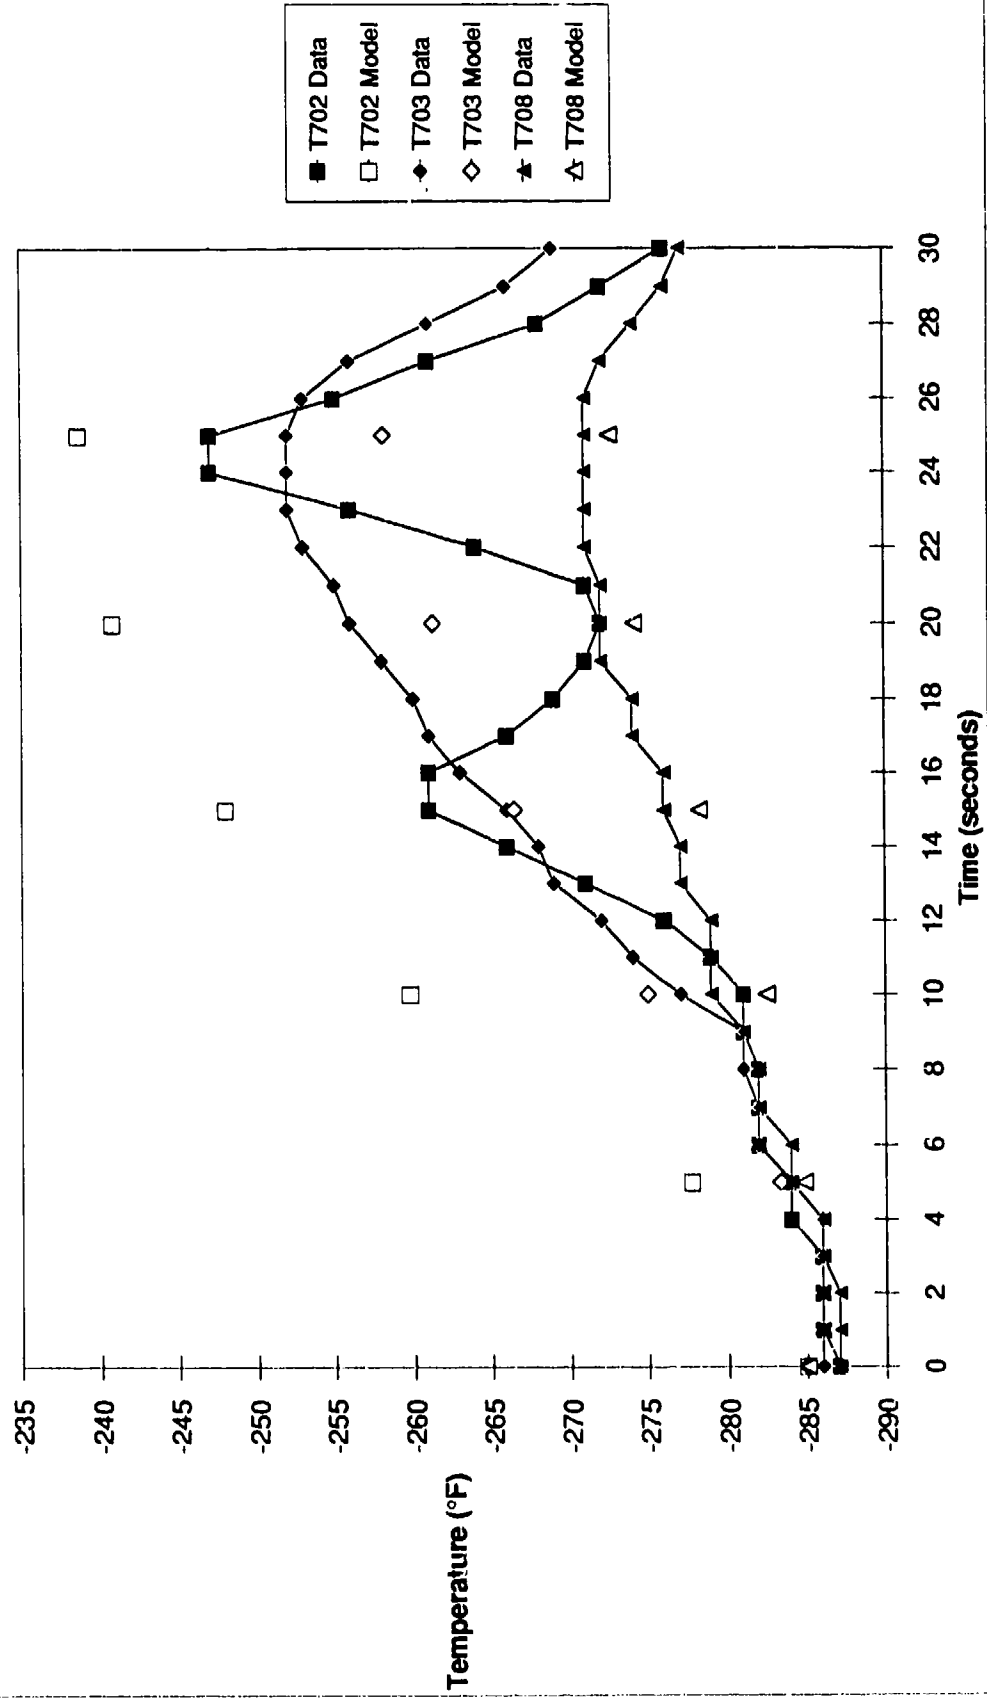
Figure 47

Test WS04C: Data vs Frictional Heating Model Comparison

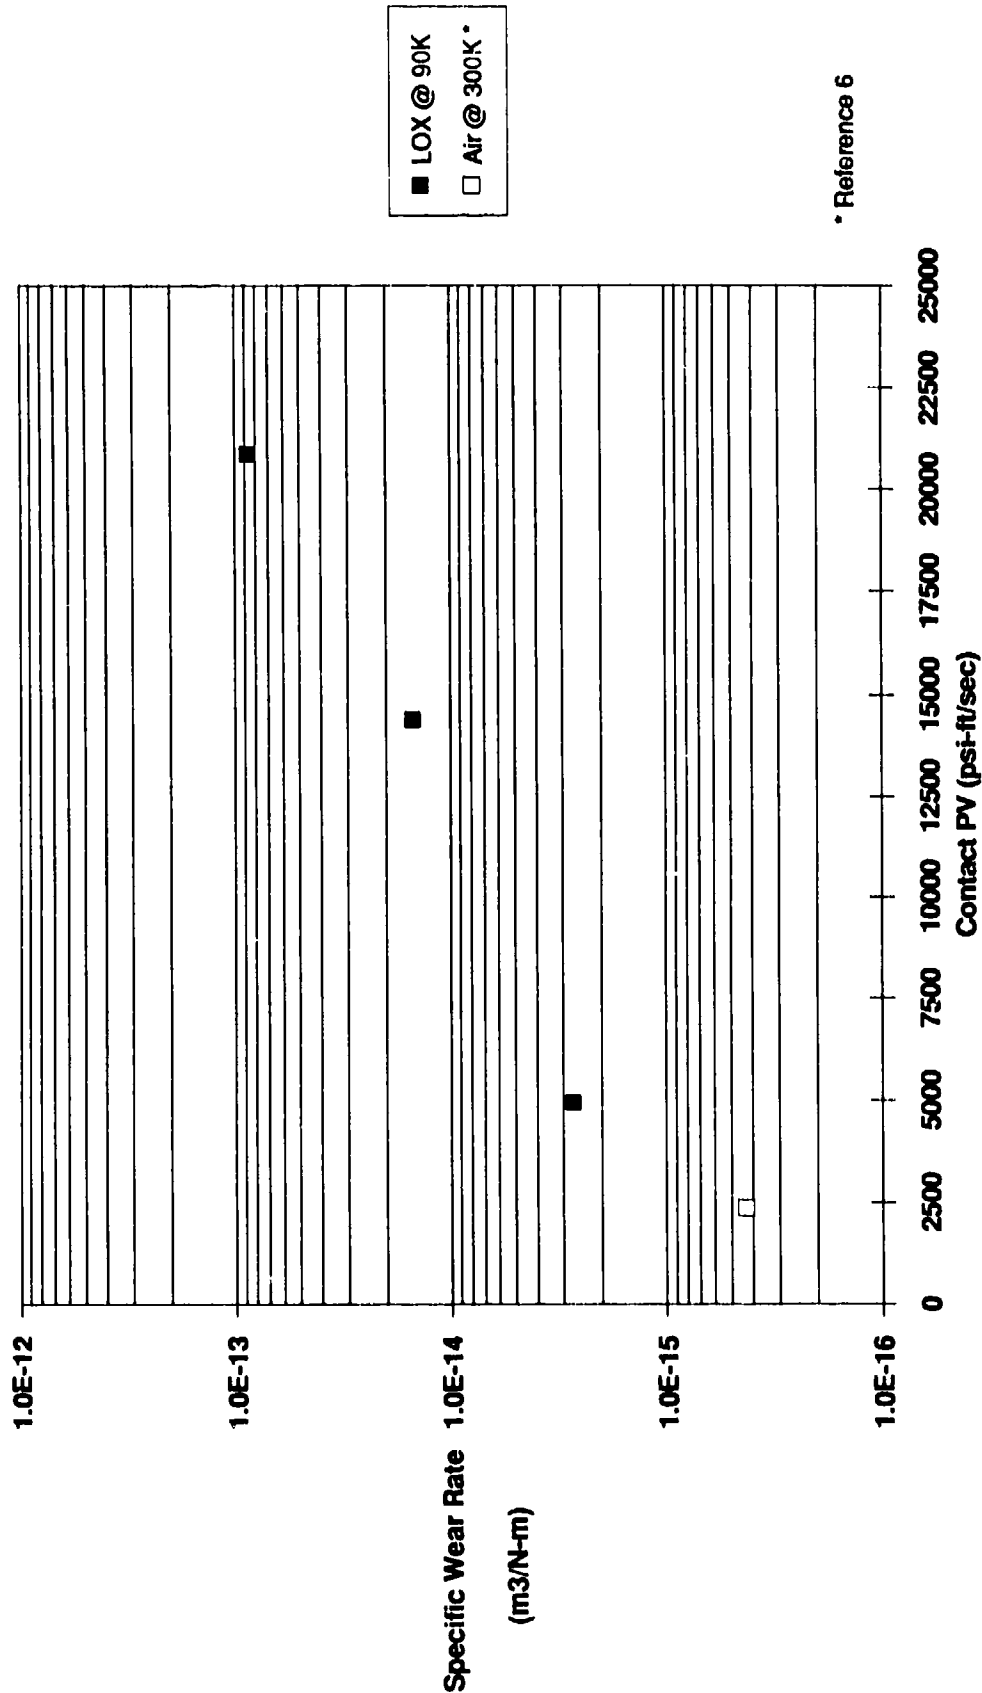
Figure 53

Measured Specific Wear of Vespel SP211

A cumulative specific wear rate for the tests WS04B through WS06, which were run consecutively, was determined using profilometric measurements. In contrast to test WS03C, the wear for these tests was milder. The value of $3.5 \times 10^{-14} \text{ m}^3/\text{Nm}$ lies within the acceptable range of PVISWR for many unfilled thermoplastics (5). While no interface temperature estimate was made, it is clear from the lack of filamentous debris that the surface temperature was below the threshold of the "softening wear" regime during the tests, and that the contact PV of approximately 7000 psi.ft/s lies within the limit for the test environment used.

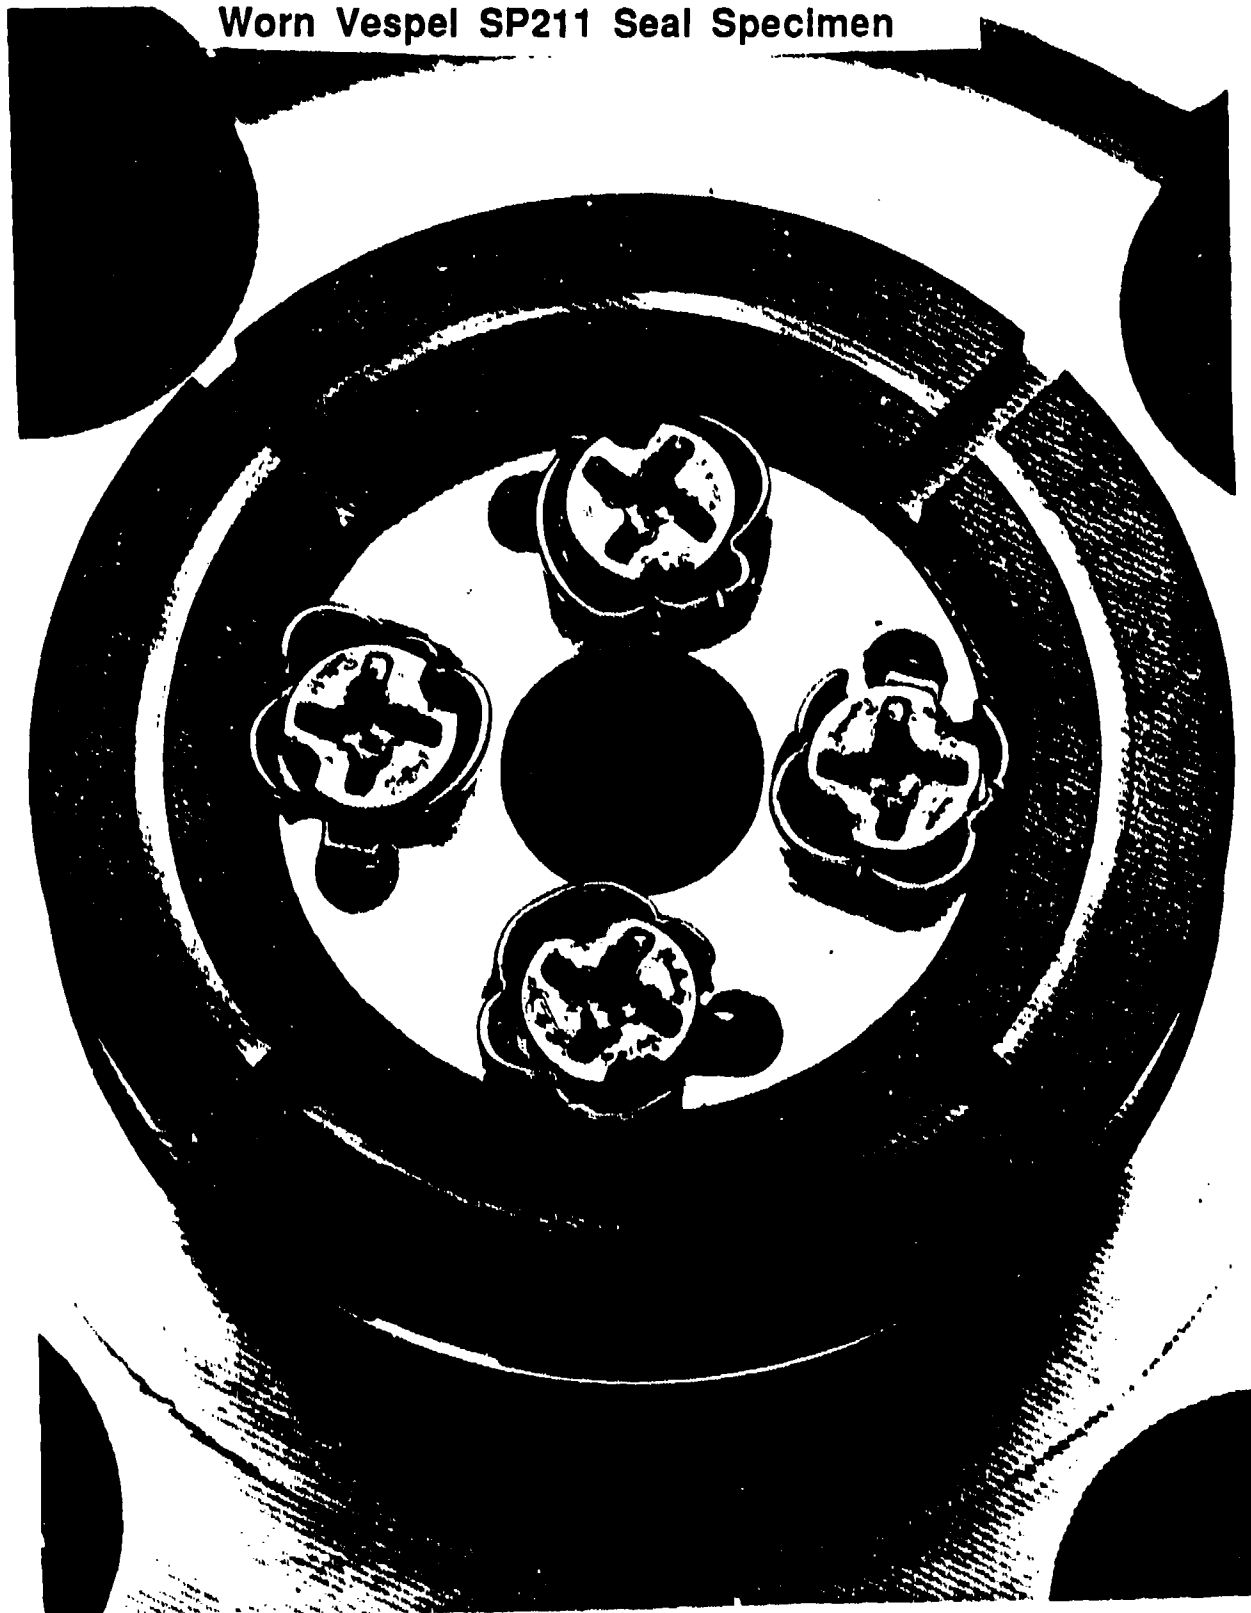
Figure 57

Test WS04C
Worn Vespel SP211 Seal Specimen

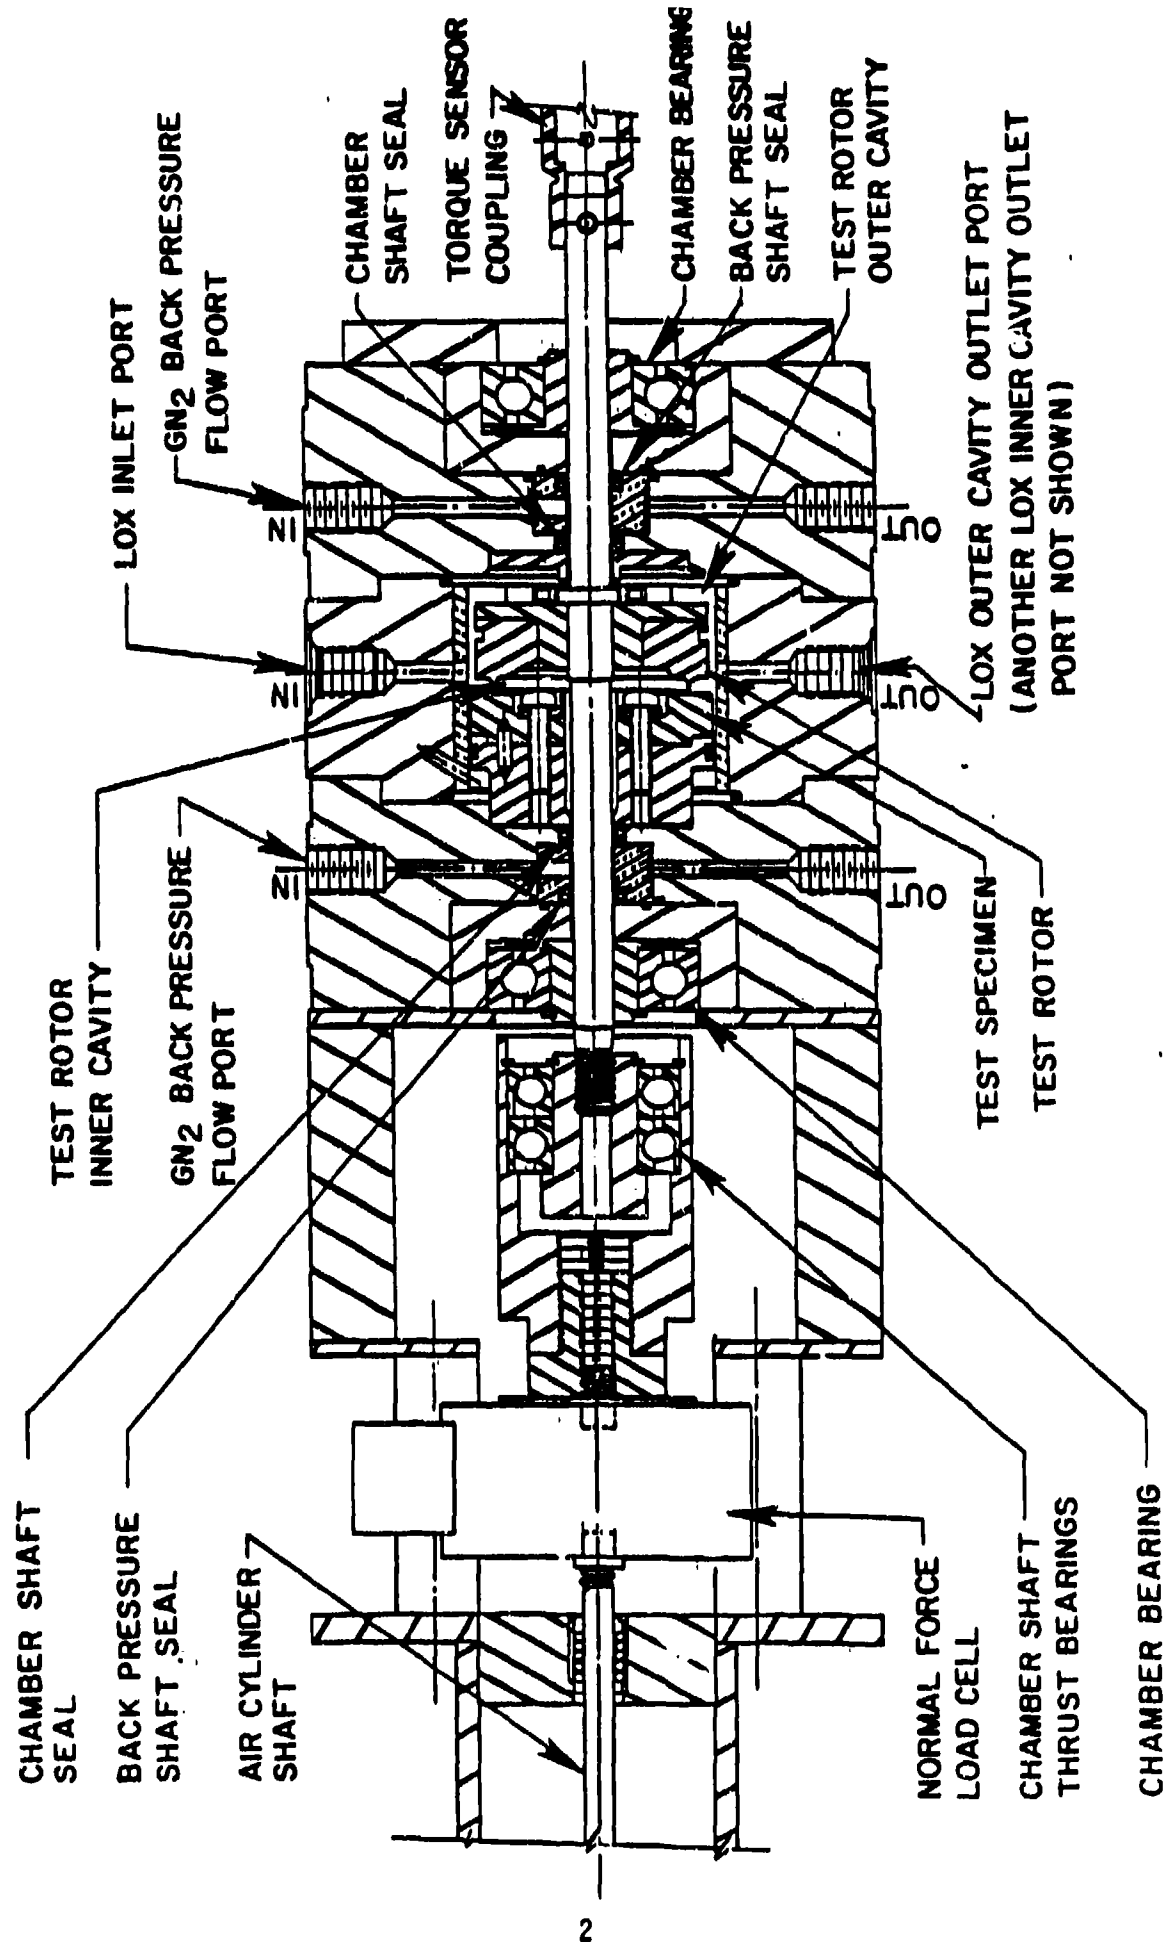
Figure 1. LOX Frictional Heating Test Chamber

Plumbing modifications were made to the test system in order to provide a continuous flow of LOX through the test chamber during the performance of a test (Figures 2 and 3). Prior to a test, LOX was fed into the system from a 150-gallon-capacity (568 L) dewar to chill the system to cryogenic temperature. A gaseous nitrogen (GN_2) purge system was used to prevent excessive chilling of the chamber shaft seals (Figure 1), and was later used to inert the system at the conclusion of a test. When the
